Kristján Sæmundsson (ÍSOR) og
Jeffrey A. Karson (Dept. of Earth Sciences, Syracuse University)
Stratigraphy and Tectonics of the Húsavík–Western Tjörnes Area
October 2006

Stratigraphy and Tectonics of the Húsavík–Western Tjörnes Area

Prepared for Alcoa and HRV Engineering

ÍSOR-2006/032

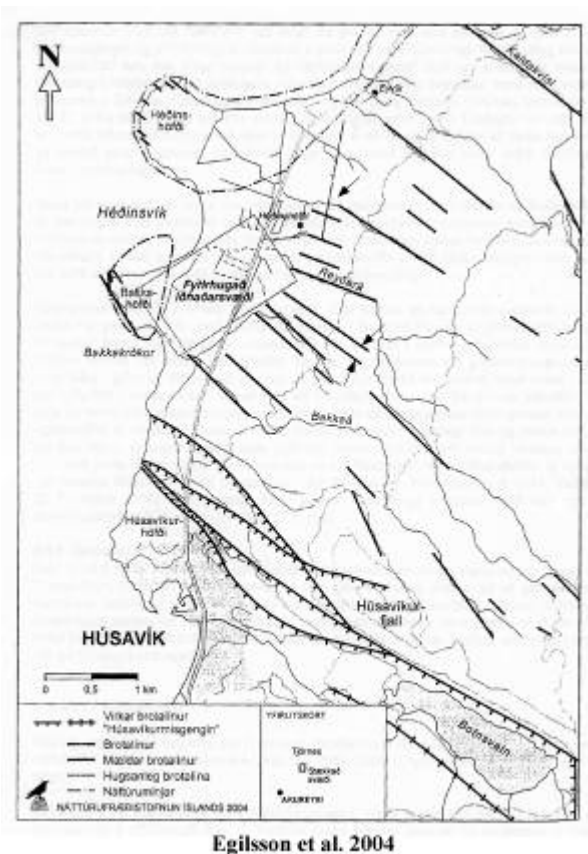
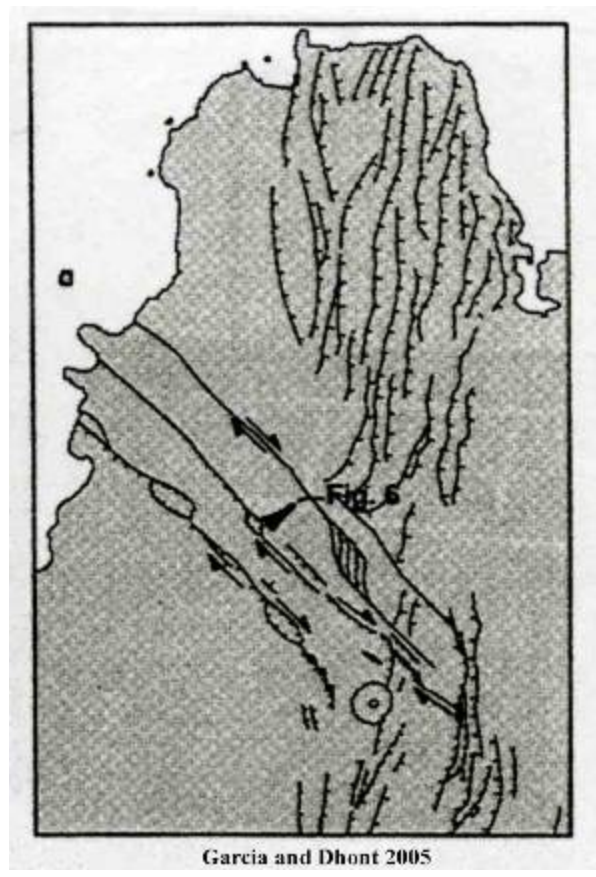
Figure 1 i-k.

Figure 1 i: *Arrows point at two overgrown NW-SE furrows which were trenched. Faults were not seen in them. A suggested fault trending NNE-SSW is also marked by arrow farther north. No indication of a fault was found there either.*

We had trenches dug across two of the most prominent lineaments down to hardened conglomerate or moraine. These two are marked by arrows on Figure 1 i. Near its base, the soil above contains a nearly continuous, yellowish, rhyolitic ash (so called S-layer, from Askja volcano, here about 5 cm thick). It is 11,200 years old, i.e. earliest Holocene (the Holocene began 11,450 yr ago). Several other, more or less continuous, centimeter-scale, ash layers are also present in the walls of the trenches. No disturbance attributable to faulting was seen. We are confident that the same applies to other grooves and lineaments in the area that have been proposed as faults on the various maps.

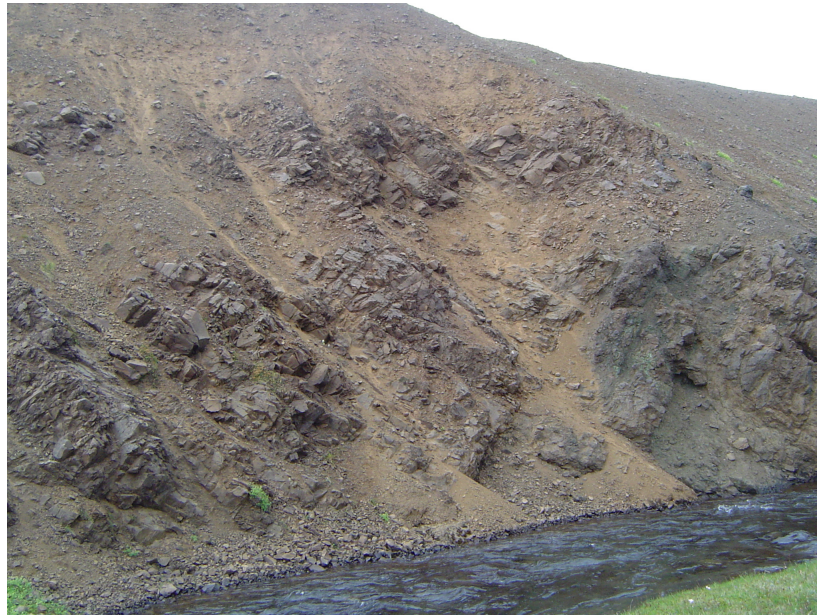
Figure 2. *Miocene basalts (Unit 1) dipping about 30° NW. Debris filled fault dipping SE in right of picture.*

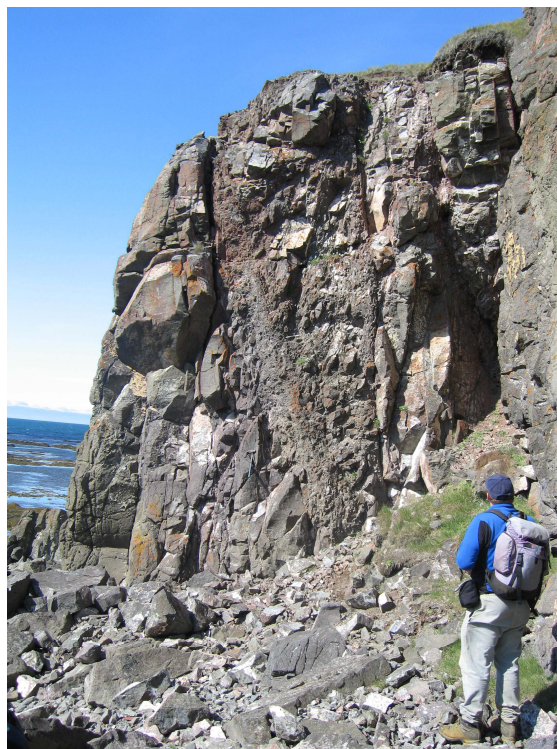
Figure 3. *Faults are very common in the Miocene basalts (Unit 1). Some of them are filled with cataclastite.*

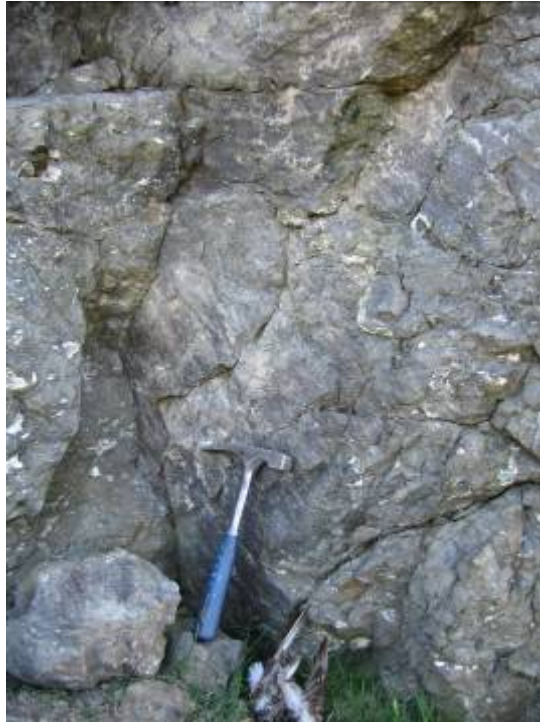
Figure 4. *Miocene basalt (Unit 1). The basalt of Unit 1 as a rule is strongly fractured and infilled with zeolites. Striations are very common and well preserved.*

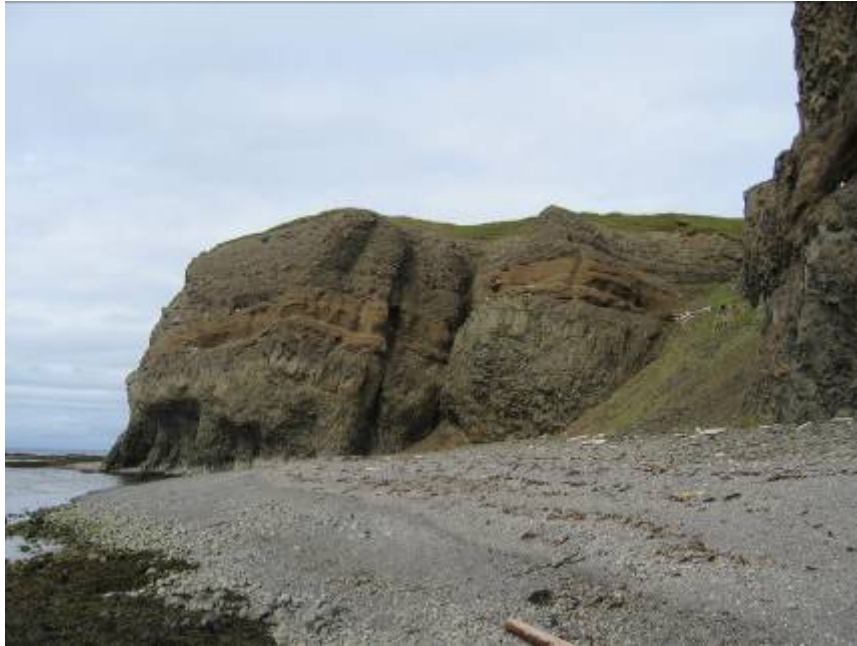
The flows dip 5-15° to the northeast and are cut by both normal and strike-slip faults mostly trending N35-45°E and N10W-N10°E, respectively. Most of the faults have vertical separations with down-to-the-NW displacements (Figure 6). Faults with displacements of less than a few tens of centimeters are marked by damage zones with high fracture density but little grain-size reduction. Consequently, these appear to be rather permeable structures as is indicated by seepages. Faults with larger displacements have well-defined gouge zones and are probably impermeable. Consistent tilting of lava flows and bedding indicate planar, domino-style normal faulting. Fault surfaces are in some cases lined with amorphous silica (opal). A major NW-trending, dextral strike-slip fault marks the northern limit of this unit. The amount of displacement on this fault could not be determined because of a lack of appropriate offset markers.

Figure 6. *Sea cliff in the SW of Héðinshöfði (Unit 4). Sediment overlying entablature flow. The faults trend N30-40°E.*

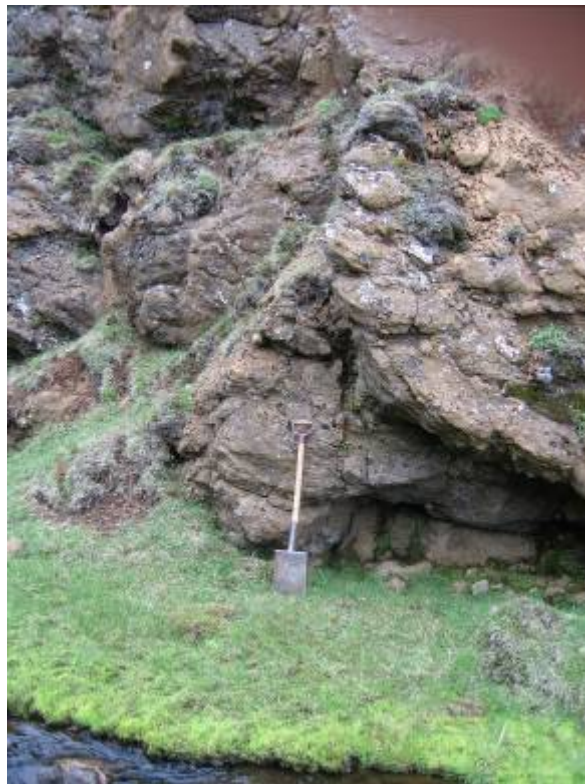
Special attention was paid to fracturing of Unit 6 hyaloclastite breccia north of the Húsavík Faults as it covers the lowest part of the slope east of the proposed plant site. This made it possible to observe to what degree faulting affected Late Pleistocene rocks in this specific area. The breccia is cut by dominantly N-S and fractures and faults, most of them showing centimeter-scale displacements. NW-SE trending fractures occur also. The small number of these is probably due to the exposures which follow this trend (Figure 7). Dip-slip and oblique-slip displacements were observed. Exposures are mostly limited to three stream cuts, all of them shown as faults on a recent map (Egilsson et al. 2004) and trending towards the plant site. Significant faults were not found in any of these. Instead, fractures and minor faults up to 1–2 cm wide and trending in a northerly direction are common. Most of them are plugged with indurated clayey fill or fault gouge.

Figure 7. Type of fracturing observed in Unit 6 breccia (right of spade). The fractures are seldom more than 2 cm wide, with a filling of compact sand- or siltstone. Most of them have a northerly trend.

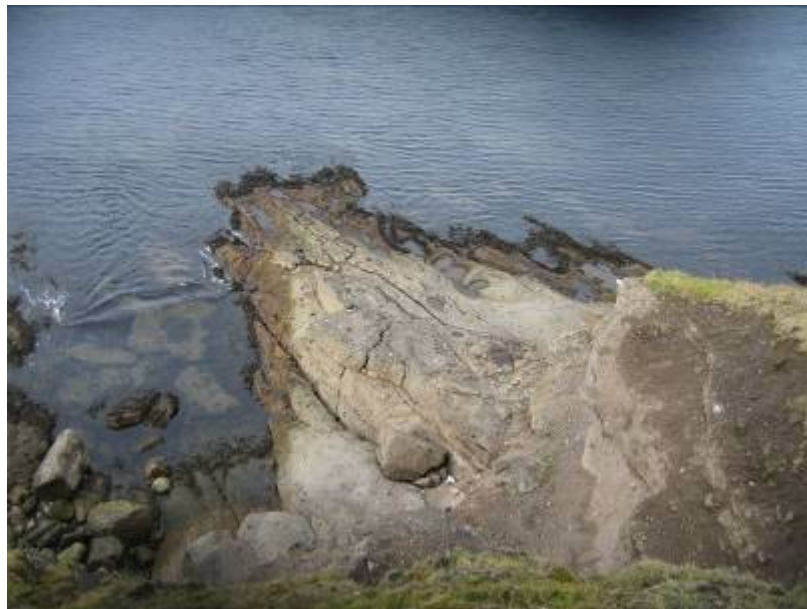
A hot spring occurs in fractures in Unit 7 tillite on the narrow wave cut platform about 100 m south of the Laugardalur Fault (Figure 9), not far from a 1500 m deep borehole in the tillite above. Warm springs also issue from fractures in the tillite at the Húsavík harbour.

Figure 9. *Fissures trending N50°W south of Laugardalur. This is part of a 40 m broad fissure zone from which hot springs well forth (60°C max.).*

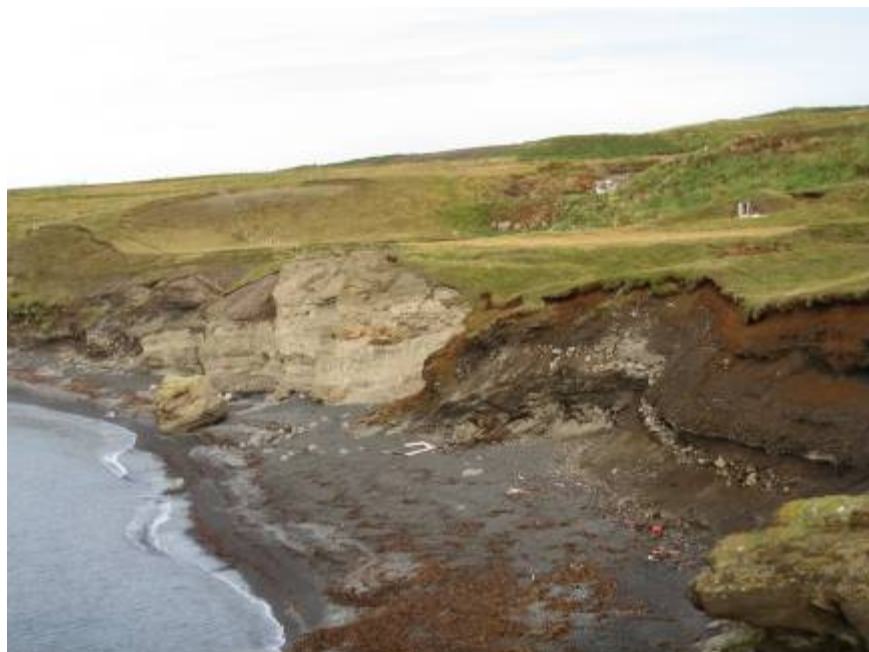
The Húsavík Faults are the obvious major seismic risk for the building site at Bakki. There are two main faults, Skjólbrekka and Laugardalur Faults. The distance between them is 500 m. We tried to define the displacement that occurred on them during the Holocene. They are exposed only in the sea cliff north of Húsavík. The coastal exposures reveal a vertical displacement of the Skjólbrekka Fault of about 4.5 m in semi-indurated loess from early Holocene. The displacement of the Laugardalur Fault could not be determined as an early Holocene reference layer was not preserved on both sides of it in the cliff (Figure 10). However, a similar throw is indicated by the size of the fault step as seen there. In addition trenches were cut by backhoe excavator and dug by hand across both faults near the shore and about 1 km east of the shore. Ash layers in the soil provide dated reference markers which make it possible to define a few disturbances in time.

Figure 10. *Laugardalur Fault (southern Húsavík Fault). The fault is about 80 cm wide filled with chaotic debris. The higher wall consists entirely of tillite (Unit 7) with 6 m of coarse gravel (Late glacial outwash) banking up against it on the lower wall.*

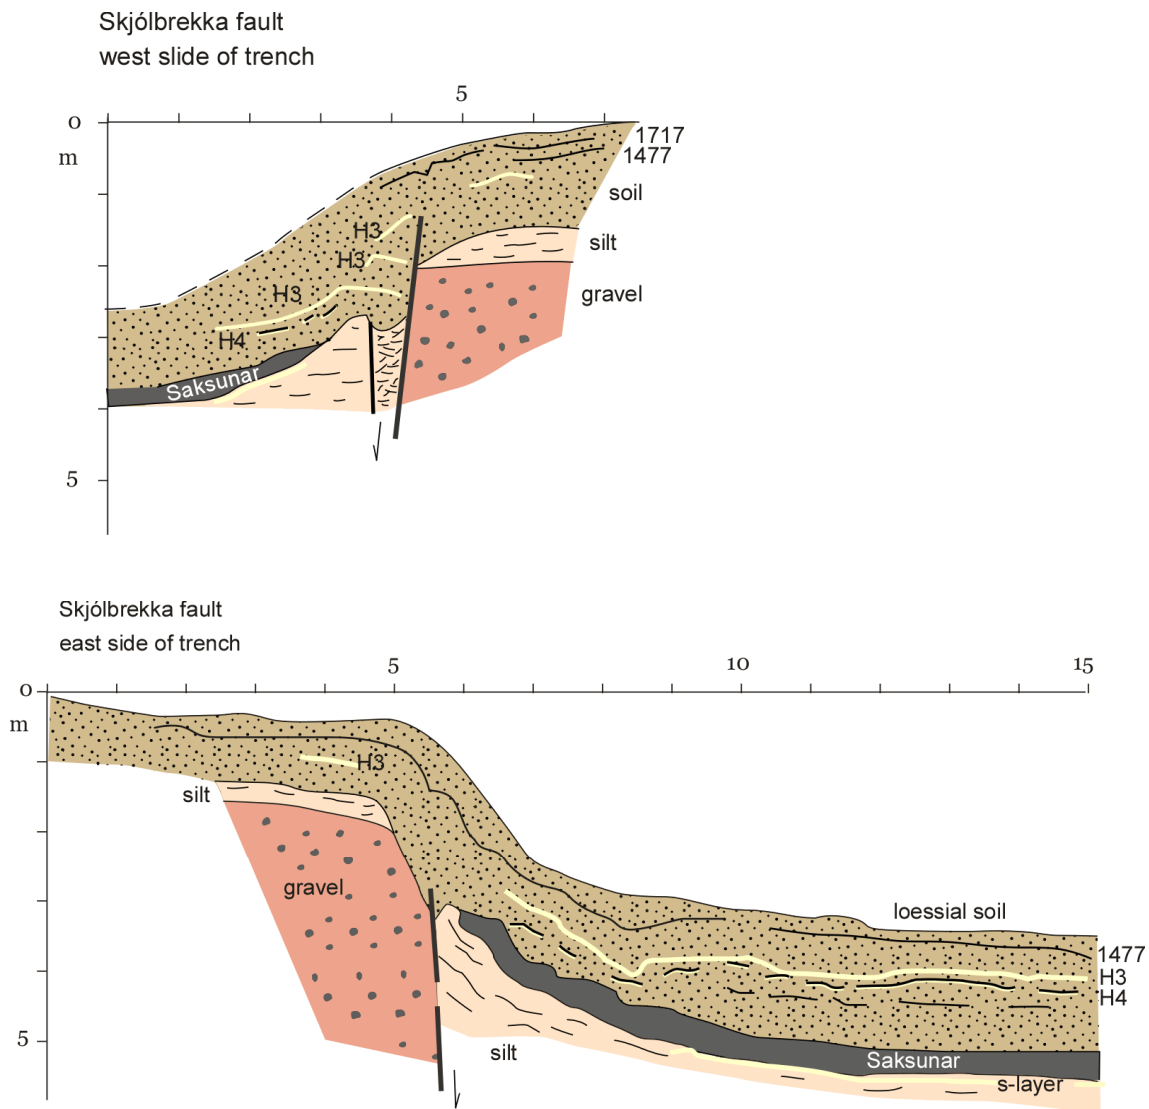
The Skjólbrekka Fault shows two distinctive faulting events (Figure 11). At least one event occurred in early Holocene, some time after deposition of the Saksunar-ash layer about 10,000 years ago. The other event occurred after deposition of the Hekla-3 ash about 3100 years ago. The total Holocene displacement on this fault is just over 4 m of which about 1 m occurred after Hekla-3. Two faulting events are on record after deposition of basaltic ash layers in 1477 and 1717 A.D., one of them in 1755, the other in 1872. The 1477 ash is disturbed, but it could not be ascertained whether this was caused by soil creep or fault slip.

Figure 11. Section across Skjólbrekka Fault. Both sides of trench. Two faulting events stand out. One after fall out of the Saksunar ash (less than 10.000 years ago) and another after Hekla 3 ash (less than 3100 years ago). The base of the silt layer is about 2 m below the Saksunar ash on the hanging (lower) wall of the fault.

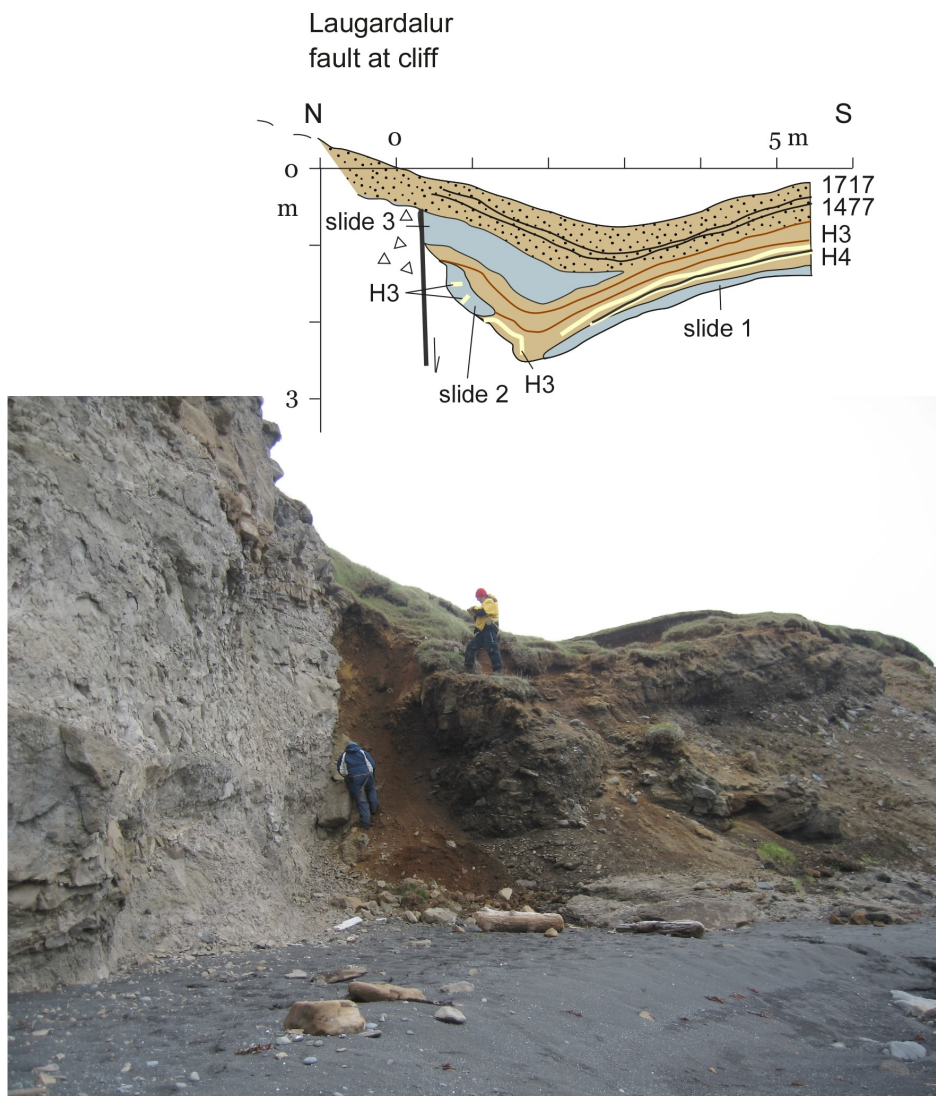
Two trenches 15 m apart across this fault at the sea cliff revealed three slides of gravelly rubble mixed with soil (Figure 12). The lowest one underlies Hekla-4 forming a slide mound close the fault escarpment. The second overlies Hekla-3. Closest to the fault wall it has partly tumbled into a fissure and beyond bending and disrupting soil which includes both Hekla-4 and Hekla-3 ashes (Figure 13) in front. The third occurs well below the 1477 ash. The 1477 and 1717 ashes are only slightly disturbed, probably due to later ground movement (1755 and/or 1872).

Figure 12. Close up of Laugardalur Fault. A soil section shown above was dug through the grass covered soil above tillite and gravel. The small mound behind the person is a slide.

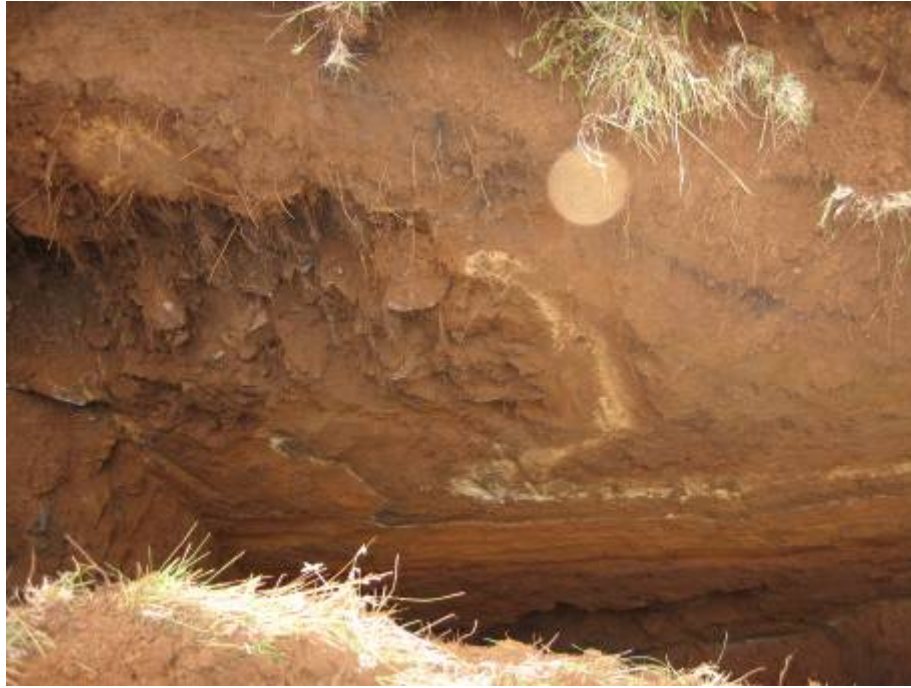
Figure 13. *Laugardalur fault showing disruption and bending over of ash layers Hekla-4 (yellow and black, 4500 years old) and Hekla-3 a little above (3100 years old). A debris slide has distorted both.*

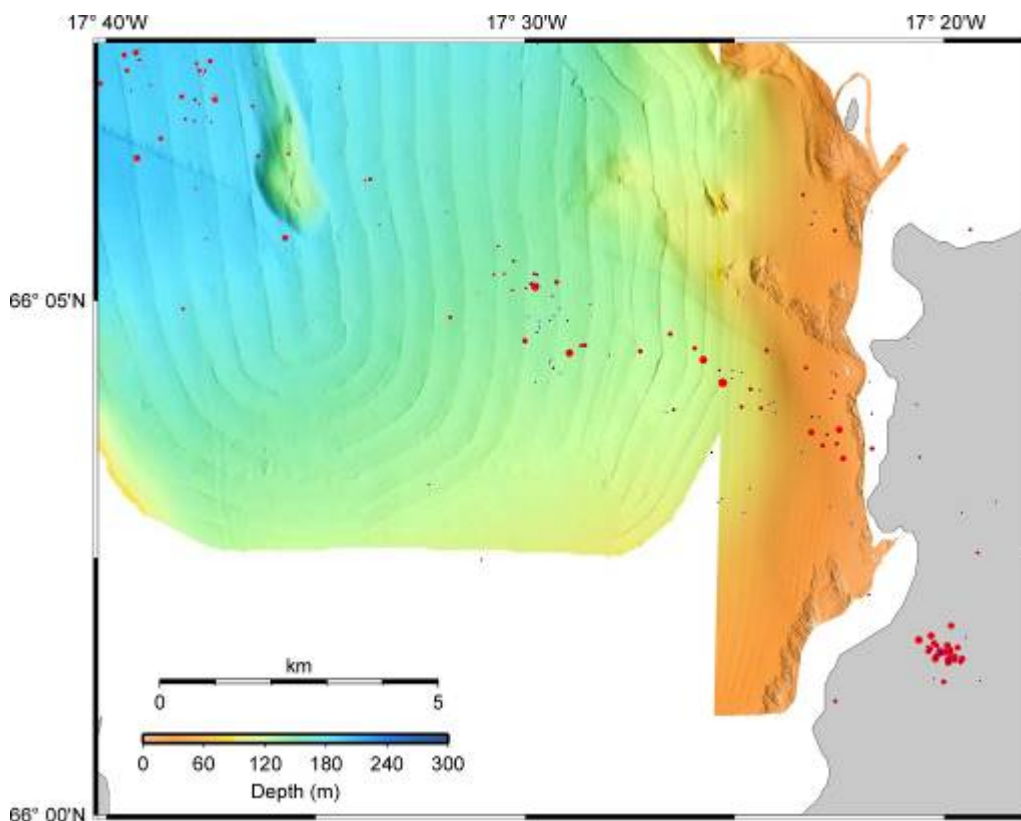
Figure 15 shows microearthquake activity of the area nearest to Húsavík from 1998–2006, after installation of additional seismometers. Here the Húsavík Faults show minor activity, i.e. the Langidalur Fault whereas the Skjólbrekka fault is quiet. A more concentrated activity of the Húsavík Faults was obtained in a microearthquake study of the Húsavík area in the summers of 1972–1973 (Zverev et al. 1978). The onshore part of the Húsavík Faults has been very quiet during this over 30 years period in contrast to the offshore part west of Skjálíandi. This might indicate that they are locked or perhaps are controlled by activity of the Theistareykir volcanic system to the east which cuts through eastern Tjörnes with faults branching off from it towards NW (Saemundsson 1974 Gudmundsson et al. 1993). There are two rifting episodes of this volcanic system on record. They occurred in 1618 and 1885. The latter episode may have been a prolonged one, beginning with an eruption at Mánáreyjar 10 km north of central Tjörnes in 1868. For comparison the “Krafla Fires”-episode lasted 10 years (1975–1984).

Figure 15. *Húsavík Faults. Seismic activity 1998–2006. The cluster SE of Húsavík is due to blasting in a rock quarry. The main activity occurs on the offshore continuation of the Laugardalur fault.*

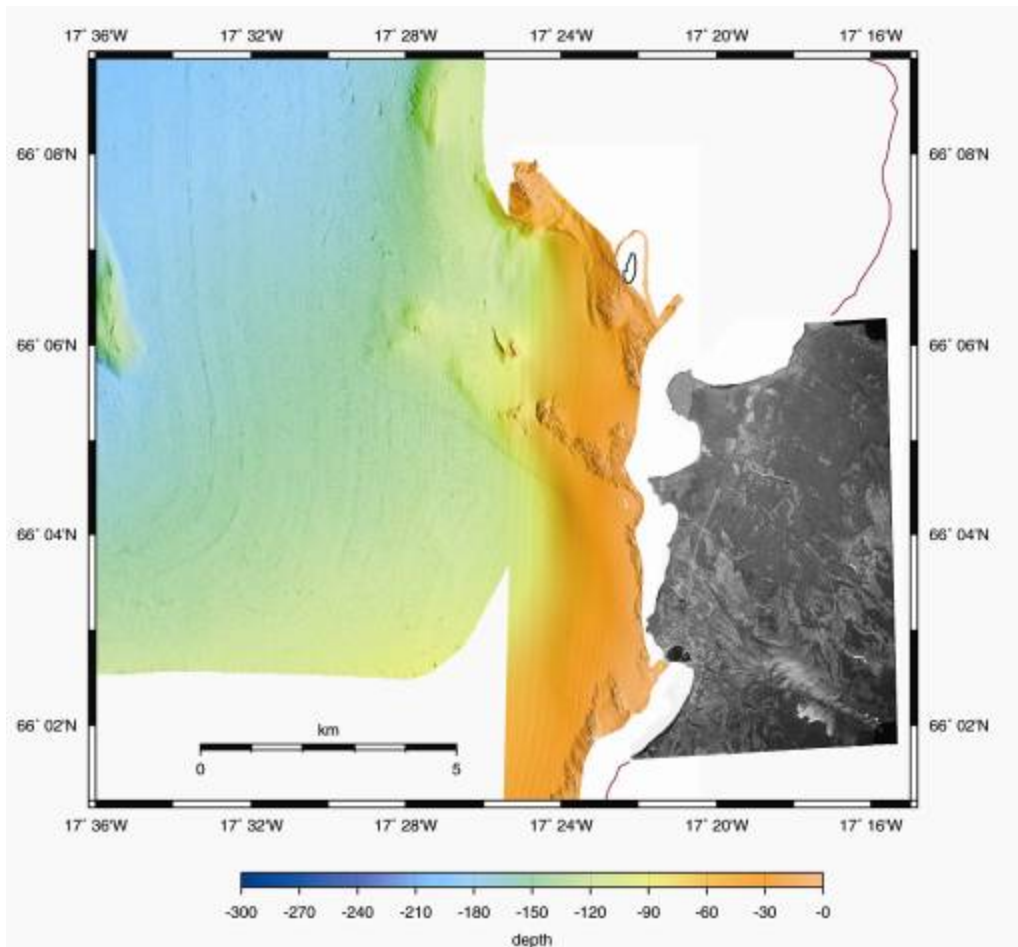
Sediment accumulation is heavy immediately west of Húsavík but nevertheless, the NW-trending Húsavík-Flatey Fault can be traced to within about 2.5 km of the shoreline just N of the town (Figure 16), probably linking to the historically seismically active Húsavík Faults. In addition, seafloor projections of coastal promontories north of Húsavík are cut by NS-trending lineaments that also appear to be active structures. Subsurface CHIRP reflection records show many more faults in the Skjálfandi area, though their orientations have not been determined.

Figure 16. Bathymetry and CHIRP reflection map of Skjálfandi, offshore to the west of the building site north of Húsavík. A fault lining up with probably the Skjálbrekka fault is visible to within 25 km off the shoreline. The two NW-trending topographic features northwest of Bakkahöfði and Héðinshöfði are most likely fault bounded on the south. A landward continuation suggesting active faults southeast of the two promontories was not found.
