Kristján Sæmundsson (ÍSOR) og
Jeffrey A. Karson (Dept. of Earth Sciences, Syracuse University)
Stratigraphy and Tectonics of the Húsavík–Western Tjörnes Area
October 2006

Stratigraphy and Tectonics of the Húsavík–Western Tjörnes Area

Prepared for Alcoa and HRV Engineering

ÍSOR-2006/032

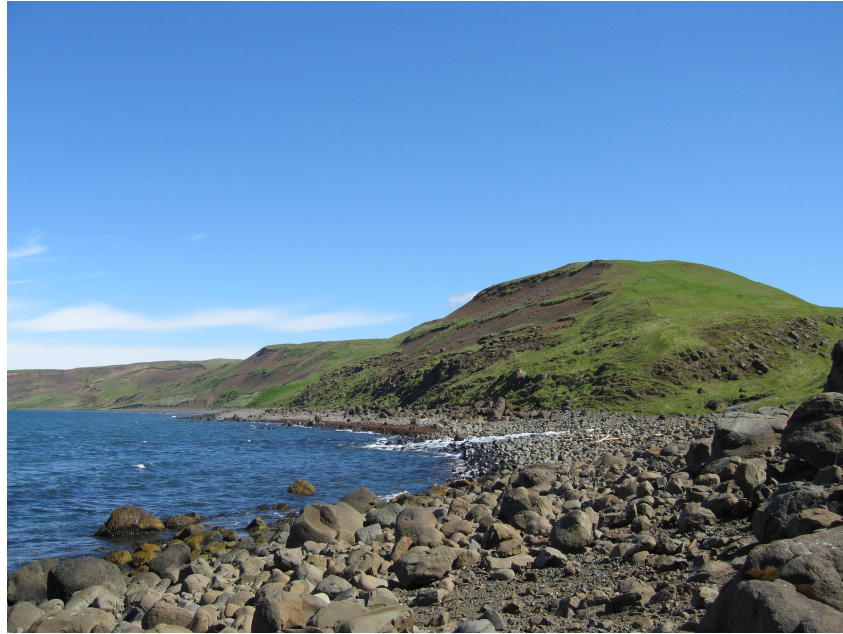
Unit 2 lava flows have a northerly dip of about 8–10°. They are less faulted than Unit 1 basalts and single members are mappable for several hundred meters in the coastal cliff, in contrast to the underlying flows of Unit 1 which are rarely tracable more than a few tens of meters. However, at Kaldakvísl the fairly regular sequence of Unit 2 is broken up by NW-SE and NE-SW faults with vertical separations of a few meters to about 10 m. Poor exposures and deep weathering prevented detailed observations of the fault rocks in this unit.

Figure 5. *Tjörnes Beds (Unit 3) conformably overlying spheroidally weathered basalt flow (Unit 2) at Kaldakvísl.*

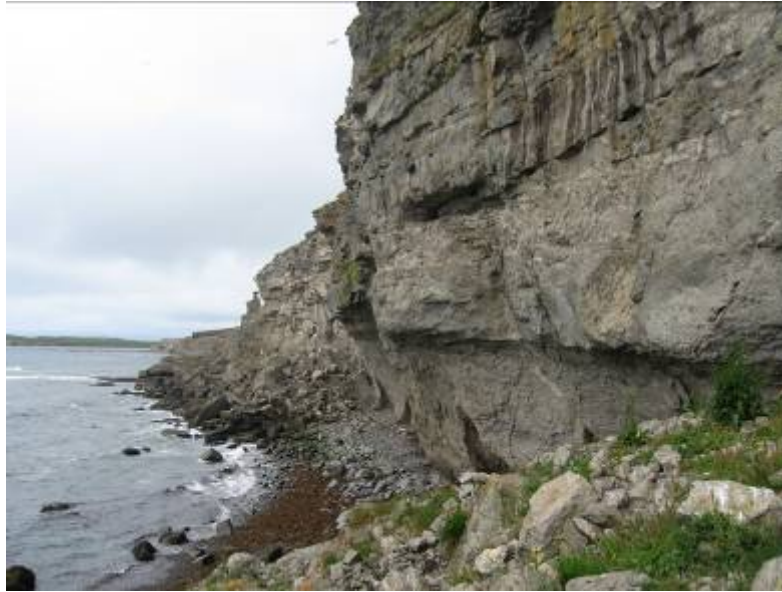
Figure 8. *Húsavíkurhöfði is made up of alternating, several meters thick layers of siltstone, sandstone and conglomerate, including tillite like boulder clays. The rock is well indurated to friable. Height of section about 10 meters.*

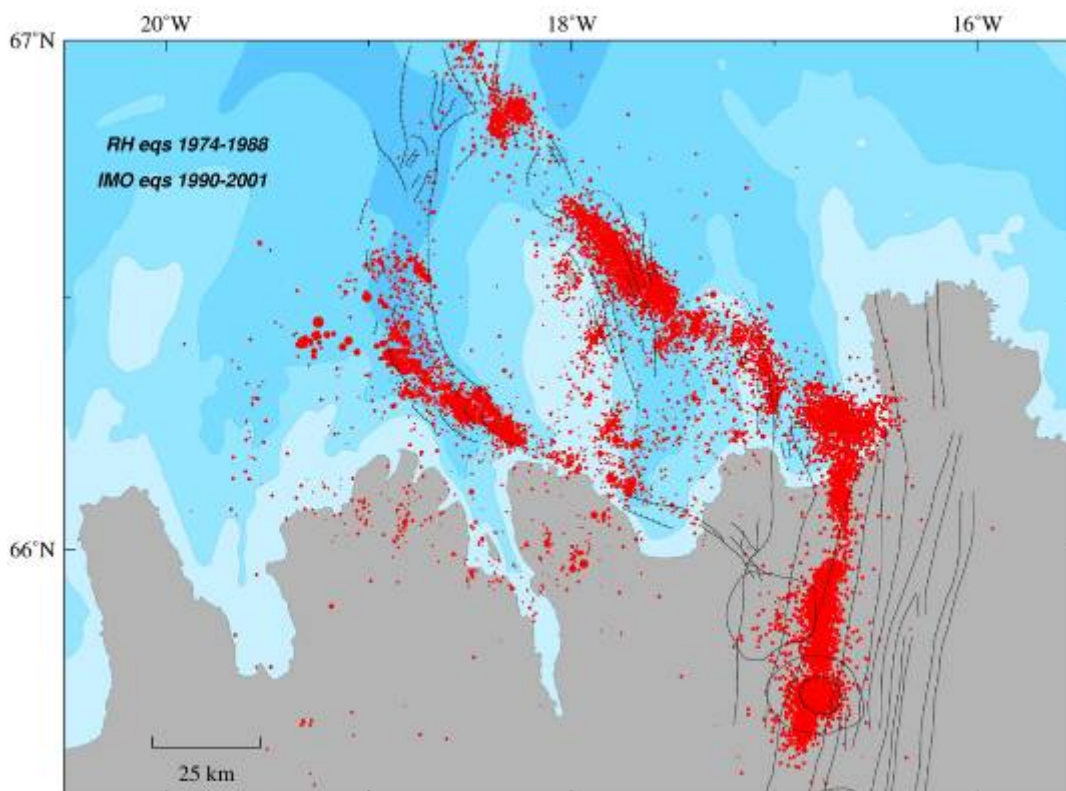
Figure 14 shows seismic activity of the Tjörnes Fracture Zone from 1974-2001. The activity is concentrated along discrete NW-SE trending fault zones. Activity of the Krafla volcanic system of the Northern Rift Zone in 1975-1984 stands out prominently.

Figure 14. *Tjörnes Fracture Zone. Seismic activity 1974-2001. Earthquakes of the Krafla rifting episode 1975-1984 in the SE of the map are included.*
